Manhole Inspection Summary

Manhole # S41I__044MH

Location Address: **1300 gough st**

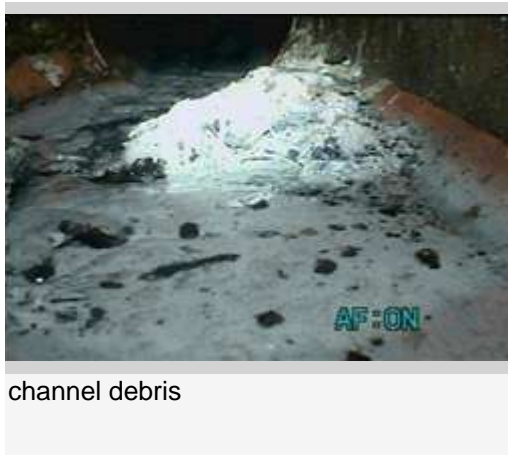
Defect 3

Condition: ☐ Sound ☐ Cracked ☐ Root Intrusion ☐ Deteriorated ☐ Leaks ☒ **Debris**

channel debris

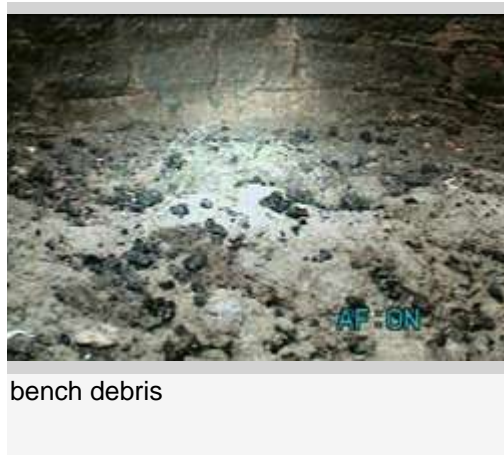
Defect 2

Condition: ☐ Sound ☐ Cracked ☐ Root Intrusion ☐ Deteriorated ☐ Leaks ☒ **Debris**

bench debris

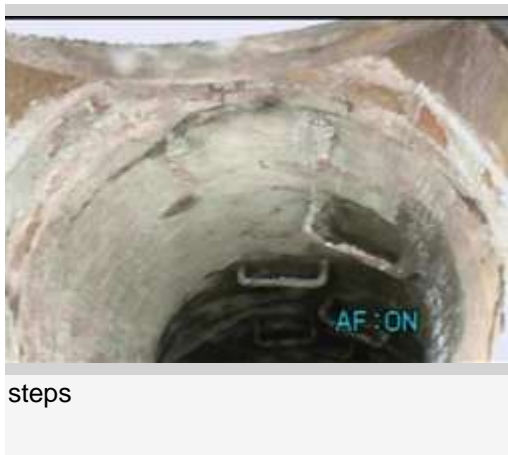
Defect 1

Count: **5** Missing: **0** ☒ **Corroded**

steps
